Federal Watershed Management Resource Centre

**MEASUREMENT OF SEDIMENT DEPOSIT IN A SECTION OF
KHULEKHANI RESERVOIR AREA
MAKWANPUR DISTRICT**

**Submitted by:
Ink Consult Pvt. Ltd
Chakupat, Lalitpur**

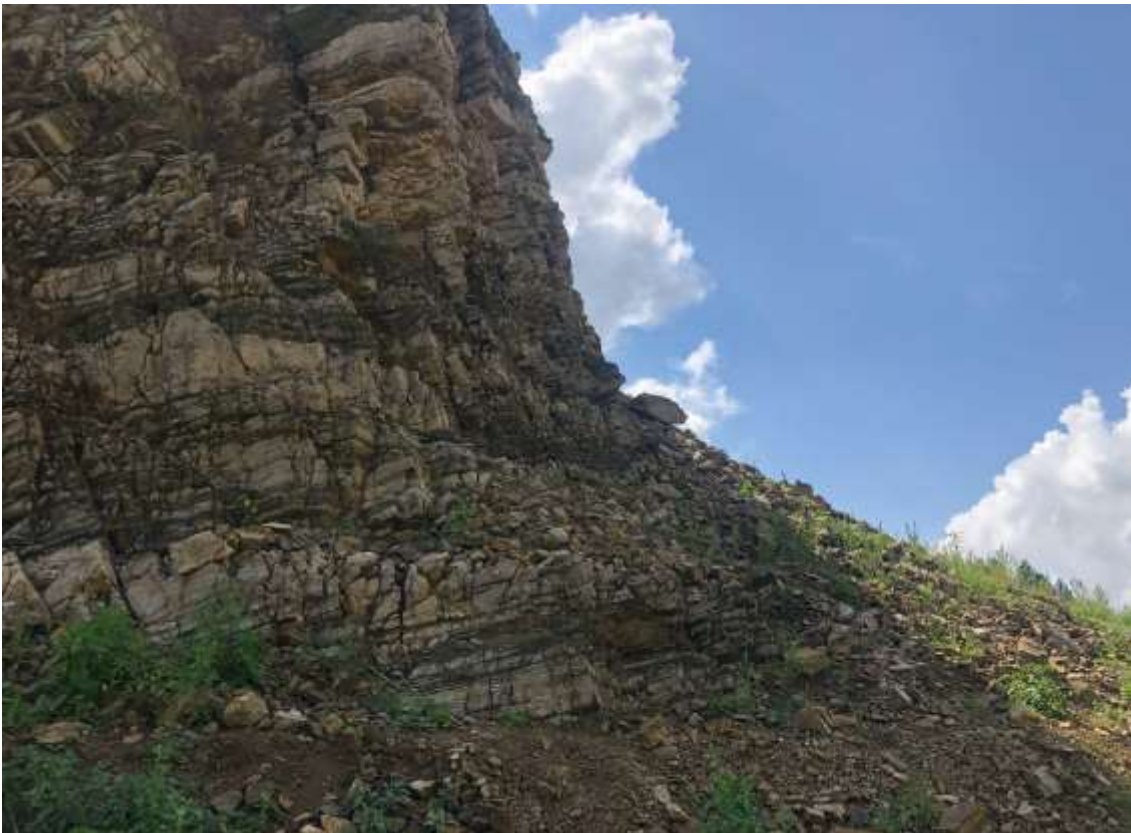
It lies on the left bank of the reservoir, 200 m downstream from the confluence of Chitlang Khola and Kulekhani reservoir. There is an exposure of highly fractured, jointed bedrock of Marble oriented due east with an inclination of 39 degrees. It is one of the potential sources of the sediment as shown in figure 5. The measurement of joints were; joint 1: 128/42, Joint 2: 328/70, Joint 3: 179/75 (metasandstone/phyllite /marble) wedge formation.

Figure 5: Moderately weathered and highly fractured bedrock on the left bank of Kulekhani reservoir (Wpt: 2463)

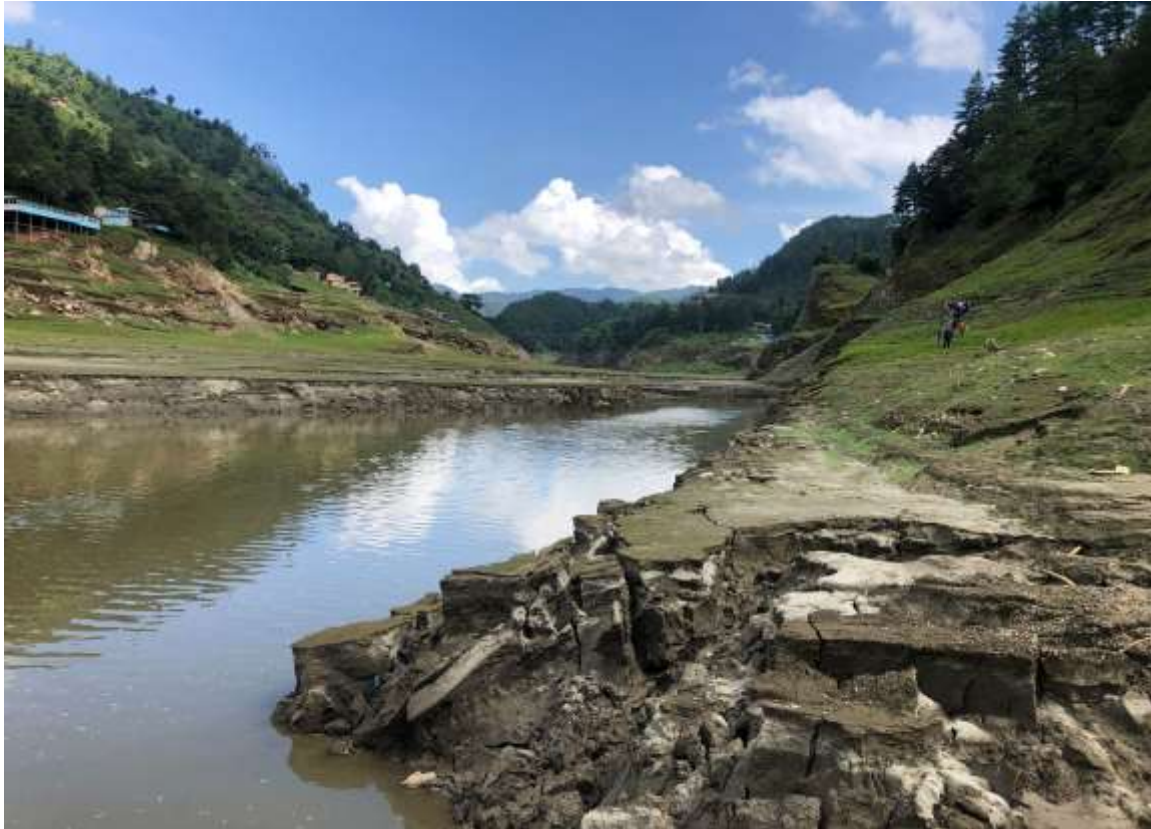
This section represents the huge accumulation of sand particles and active erosion works by the stream and major river flow as shown in figure 6.

Figure 6: Recent undercutting by the flowing water courses

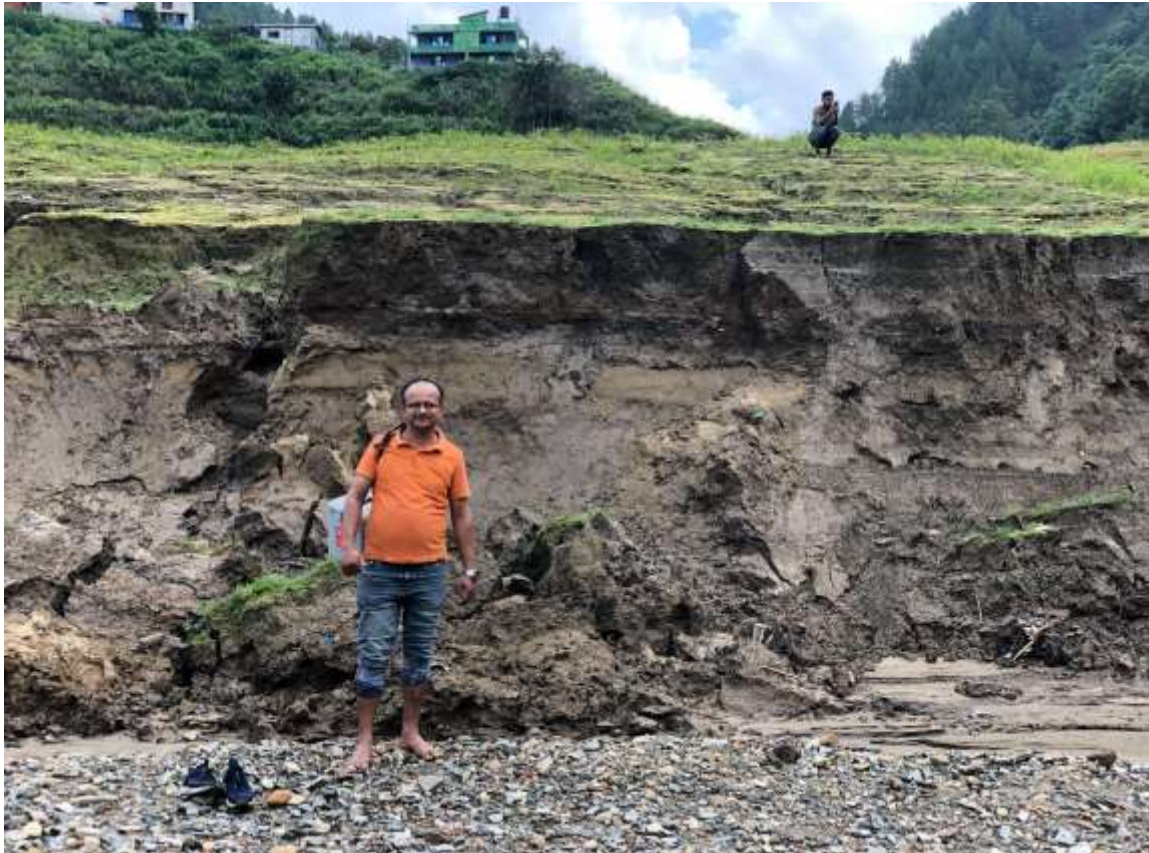
This site is located at the confluence of Chitlang Khola and Kulekhani reservoir. Muddy water was flowing during the study period which suggests that there is an active erosion work happening on the upstream of Chitlang Khola. The figure 6 represents the deposit along flood plain of Chitlang Khola. It is actively eroding unconsolidated sediment on the both bank of Chitlang Khola. The discharge of Chitlang Khola was measured to be 10197.11 cu.ft./sec. Sediment deposit was 2.5-3 m depth along the river bed composed of mixed soil/clay/sand and silt.

Figure 7: Active erosion of recent deposits along the channel of Chitlang Khola

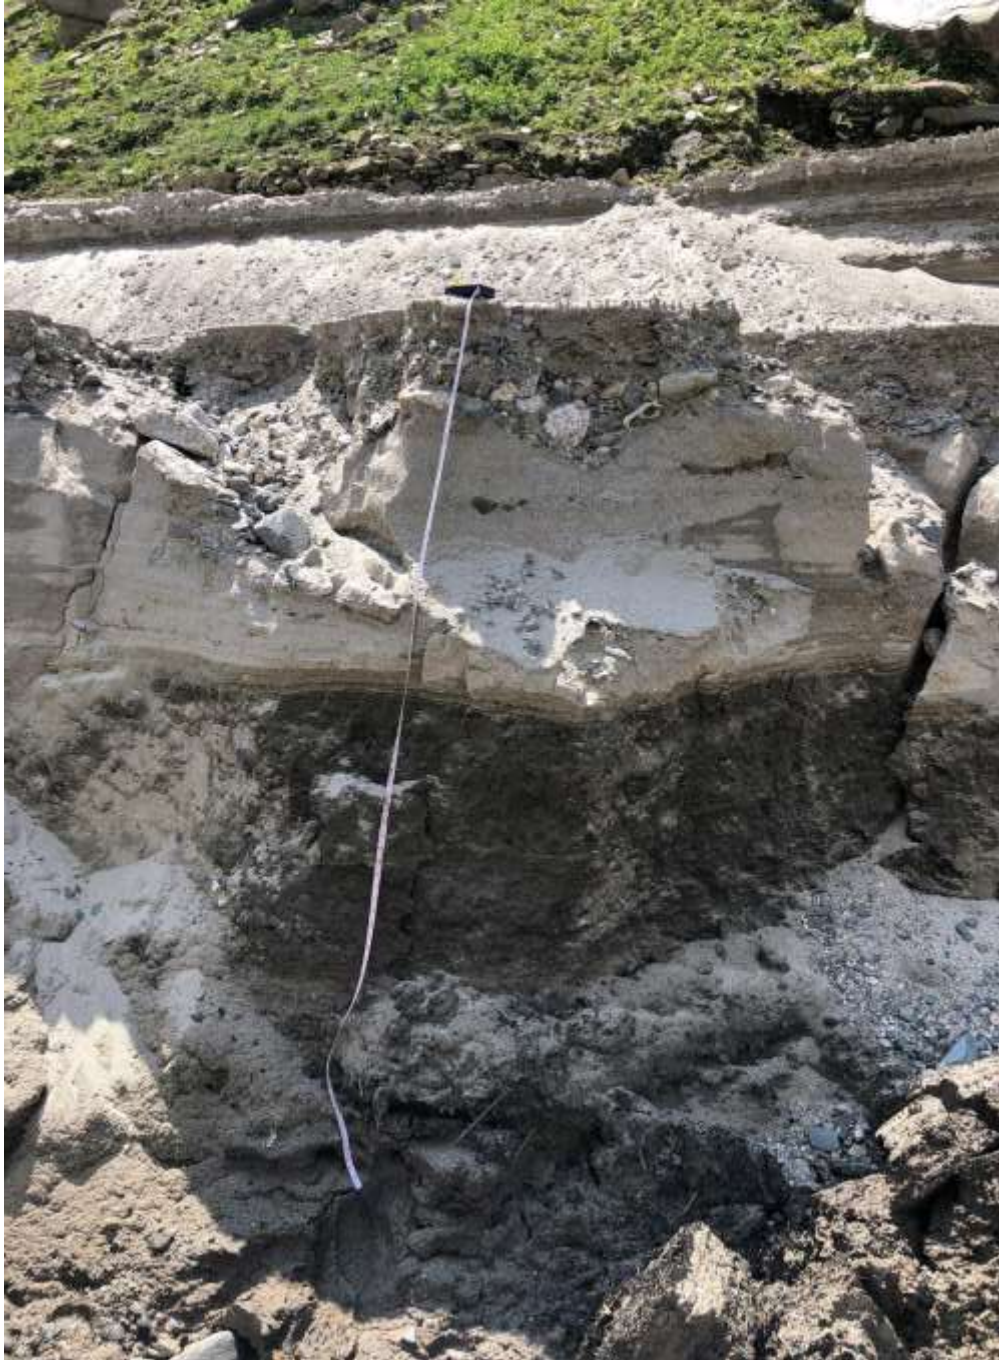
The sediment along the Thado Khola looks very recently flooded. Different layers of deposits forming terraces can be observed in figure 7 & 8. The sediment depth was 2.5 m (2 events-Jestha and Asar 2079 B.S.). The sediment comprises boulders of Palung Granite, Metsandstone and Quartzite. Layerrs, Terrace T₁ was 1.95 m depth and Terrace T₂- 1.3 m depth.

Figure 8: The sediment deposited on the left bank of Thado Khola

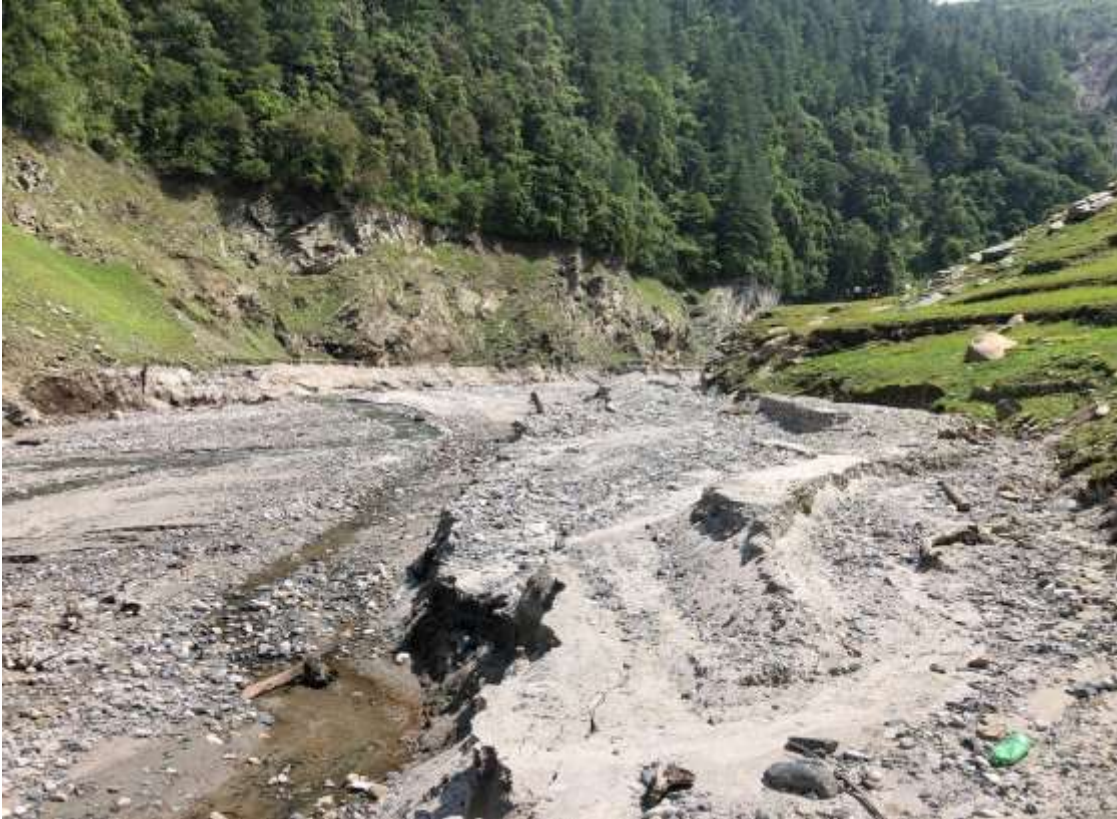
Figure 9: Very recently flooded debris collected at the bank of Thado Khola

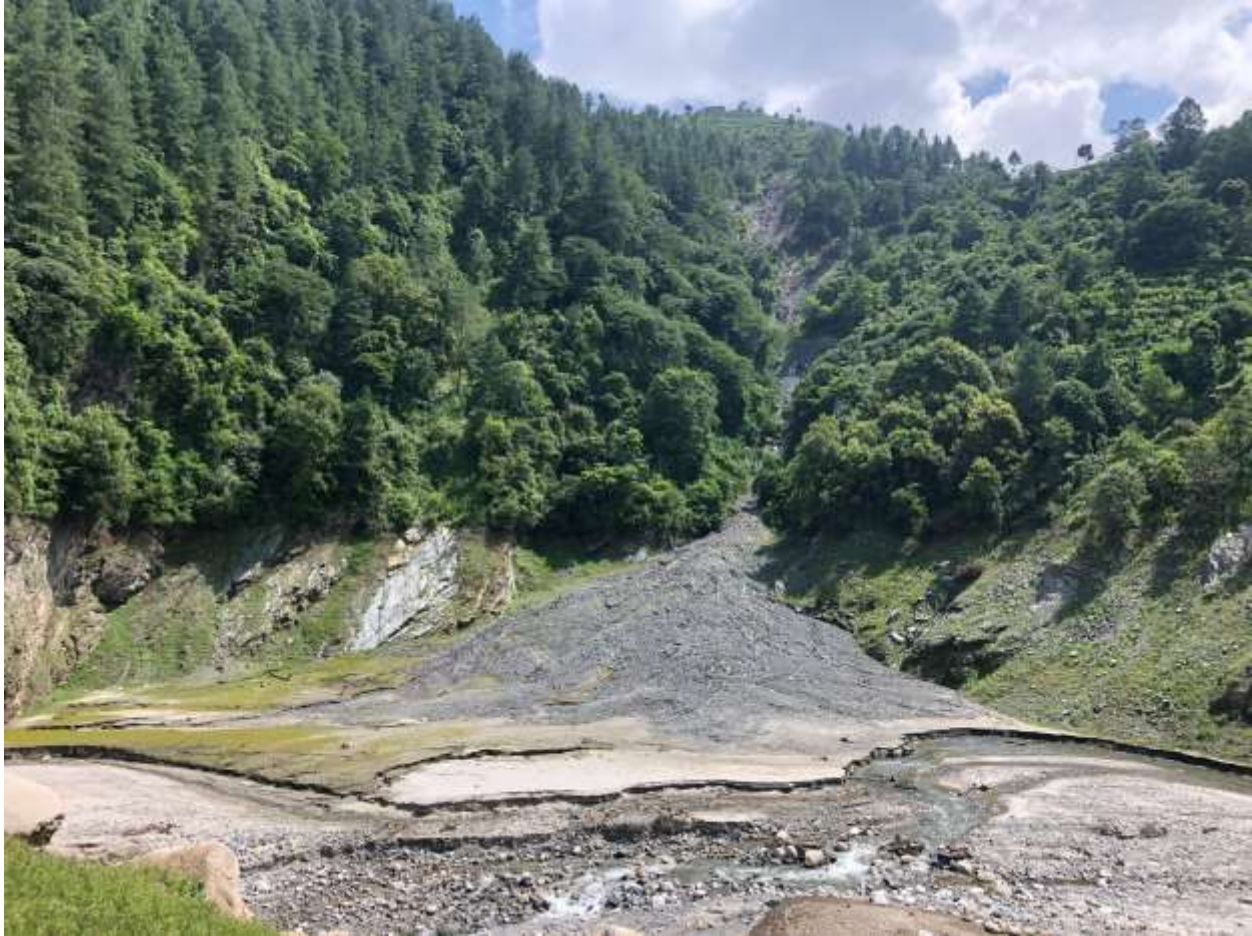
There is a landslide on the northeast facing slope 200 m south west of waypoint 2471. It lies on the right side slope meeting at Thado Khola. Erosional failure occurred due to undercut by the flowing debris and unmanaged slope. The accumulation of debris fan on the right bank of Thado Khola is being continuously eroded by Thado Khola as shown in figure 10. Small scale erosional slides occurred due to the debris flow and its influences along the flow path.

Figure 10: A debris flow occurred due to unmanaged slope after excavation and lack of control measures prior to the failure

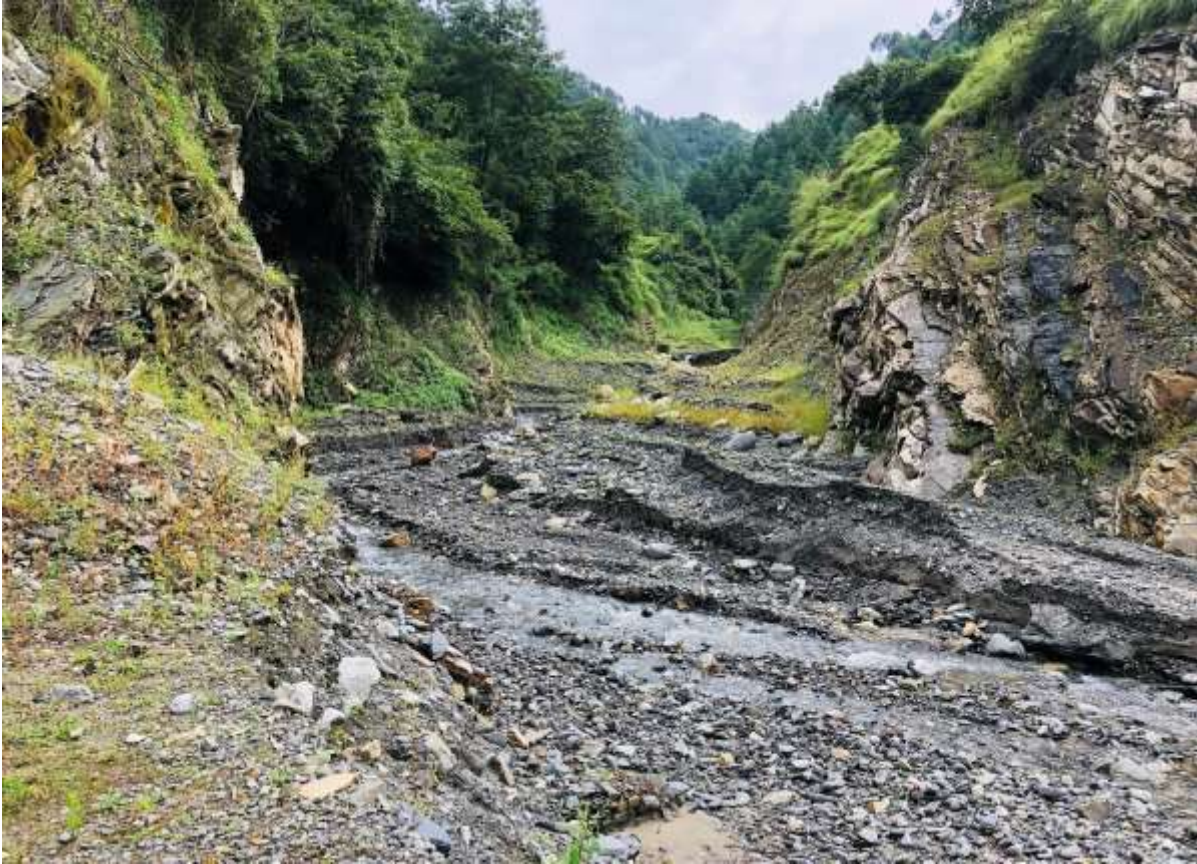
The Chalkhu Khola area comprises rock strata of Quartzite, Phyllite and Marble (interbedded). Rock beds are moderately weathered, highly jointed and fractured. The attitude of rock: S135E/44 NE and joint orientations were measured as J1-300/70, J2-210/85 and J3-160/37. Recent rainfall and the runoff through the stream contributed huge amount of sediment into the reservoir near the end section of Khulekhani reservoir. The discharge of Chalkhu Khola was measured to be 962.68 cu.ft./sec. Thickness of sediment was 2 m and actively eroded along the stream flow path and at its bank.

Figure 11: A debris flow occurred due to unmanaged slope after excavation and lack of control measures prior to the failure

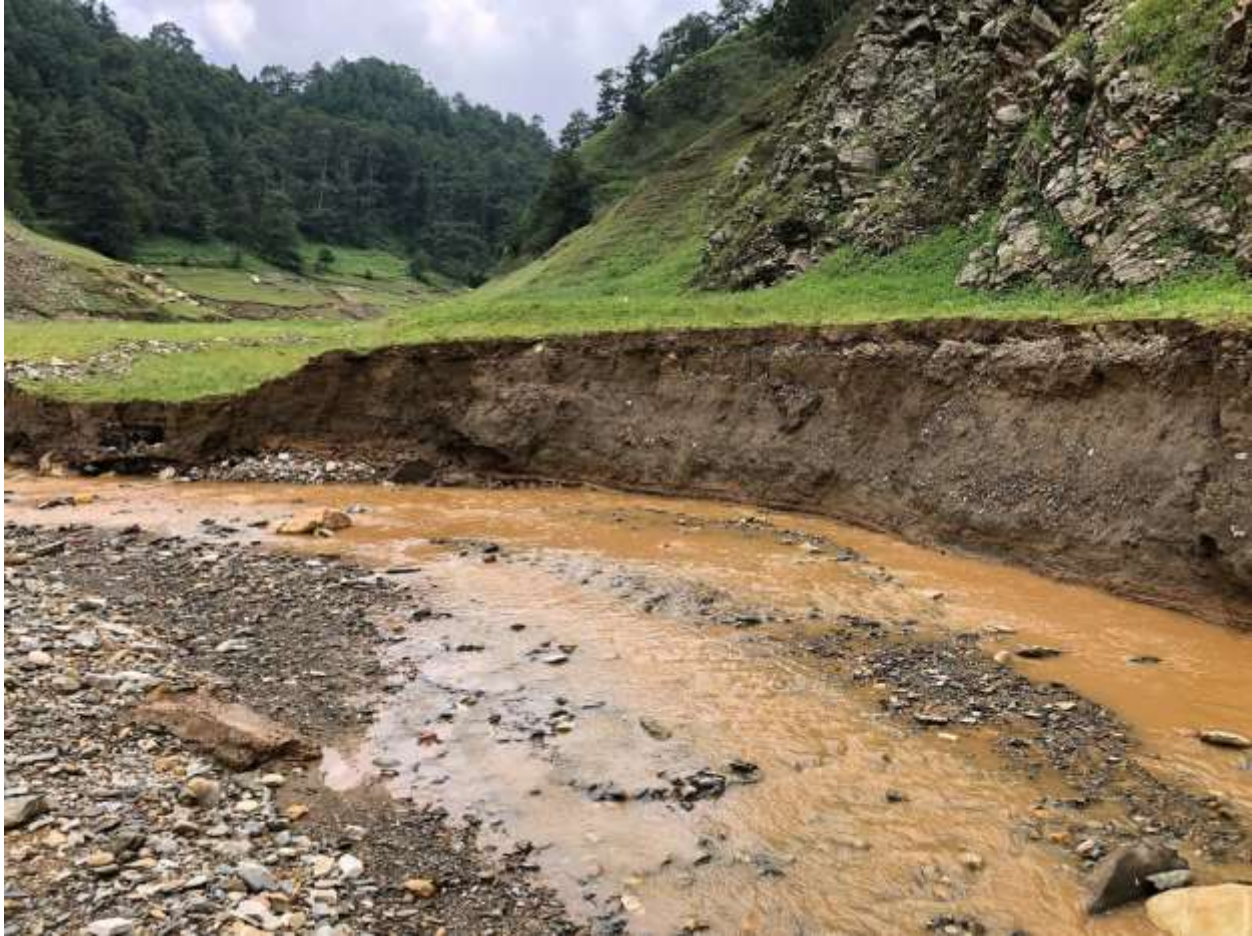
Bisingkhel Khola meets at Dhaskhu Khola which lies at E05-14-504 N30-56-201 Alt: 1508 m. Recent active erosion on the upstream is carrying out sediment can be observed during the visit. Muddy water flow during the field visit is shown in figure 12.

Gabion wall structure constructed across the Dhasku Khola was partially damaged by the stream flow. Sediment thickness was about 0.2m along the side of river bed. Basic soil types of collected sediments are silt/clay dominant. This stream has less number of boulders. The bedrocks around the stream area are; Quartzite, Marble, Phyllite and Metasandstone which are oriented northeast with inclination from 38-44 degrees.

Figure 12: Muddy water flow due to active erosion on the upstream of Dhasku Khola

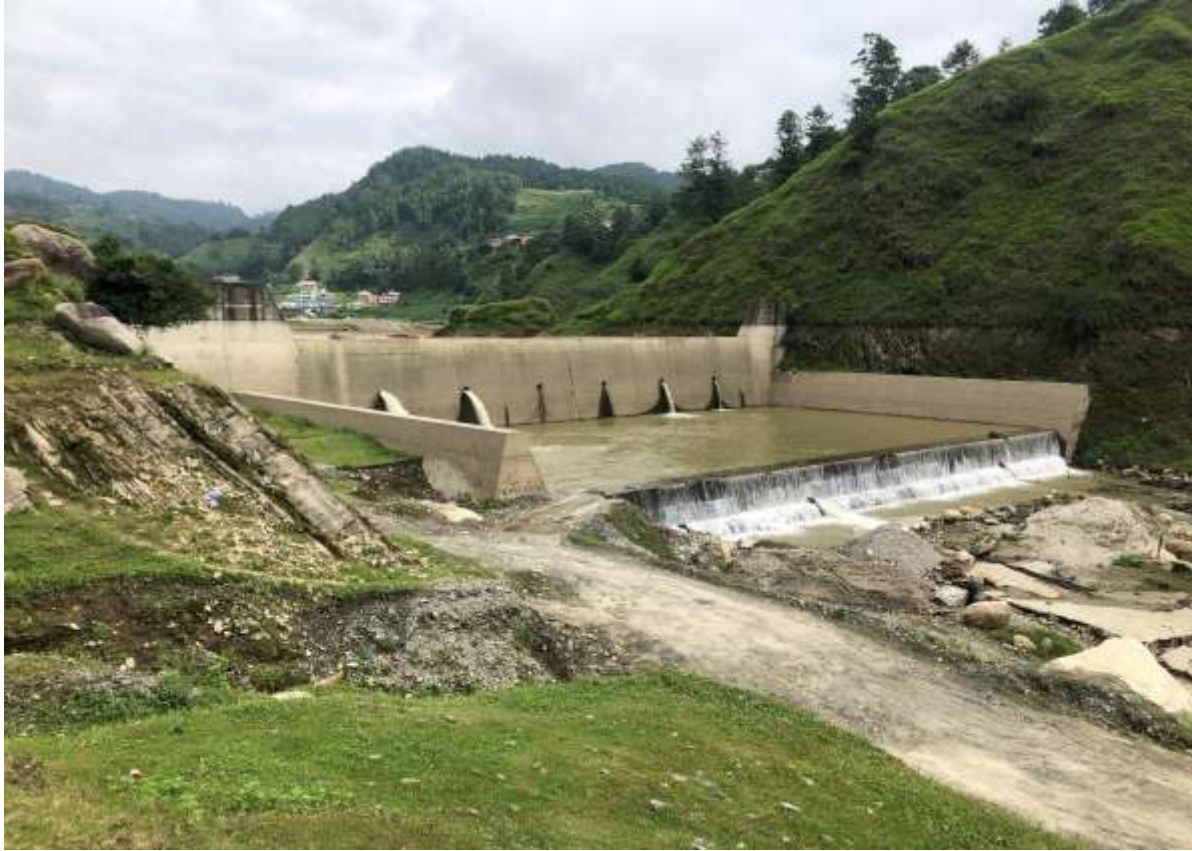
Palung Khola is one of the major streams contributing sediment into the Kulekhani reservoir. The sediment along the river section is mostly of boulder size materials of Granite, Metasandstone and Quartzite. The discharge of Palung Khola was measured to be 22311.81 cu.ft./sec. The end part of reservoir and the Palung Khola joining the reservoir is shown in figure 13.

Figure 13: Embankment across the Palung Khola constructed at end section of the Kulekhani reservoir.

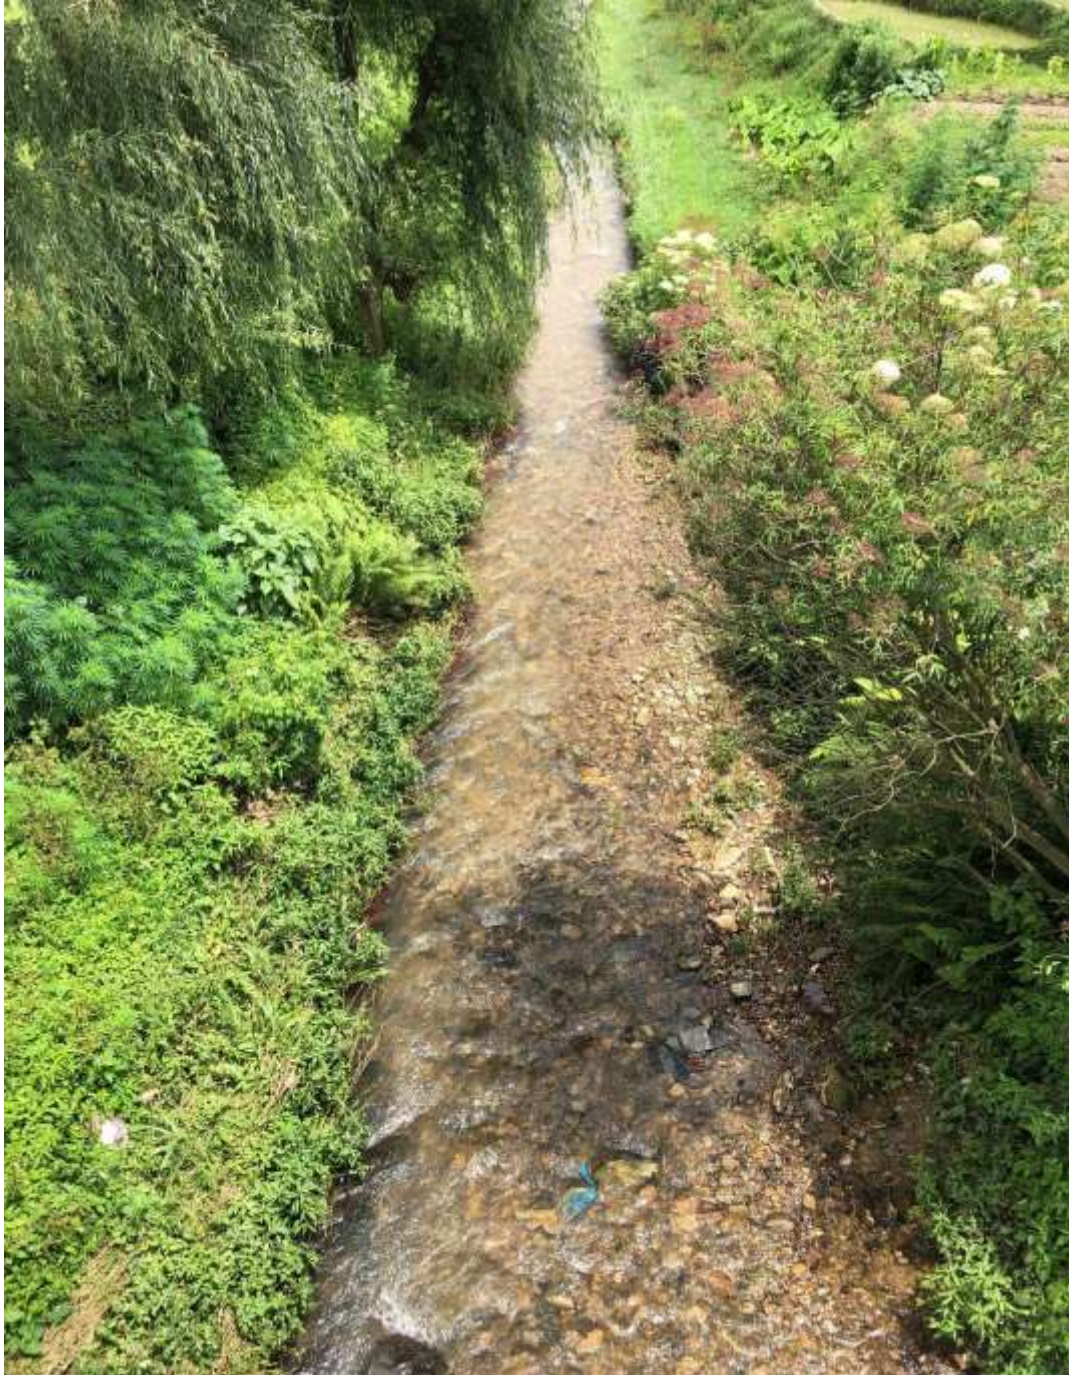
Small streams contributing to the major streams were also observed during the field visit. Streams meeting at Palung Khola (1993 flood event area) consists of boulders size materials that are present along the river bed plain. Chuliparang Khola/Bajrabarahi Khola adds up to Palung Khola in the downstream. It has gravel size materials at the river bed section. There is absence of boulders as observed around the Bajrabarahi Bajar.

Figure 14: The stream flowing below the bridge section of Saraswoti Bajar

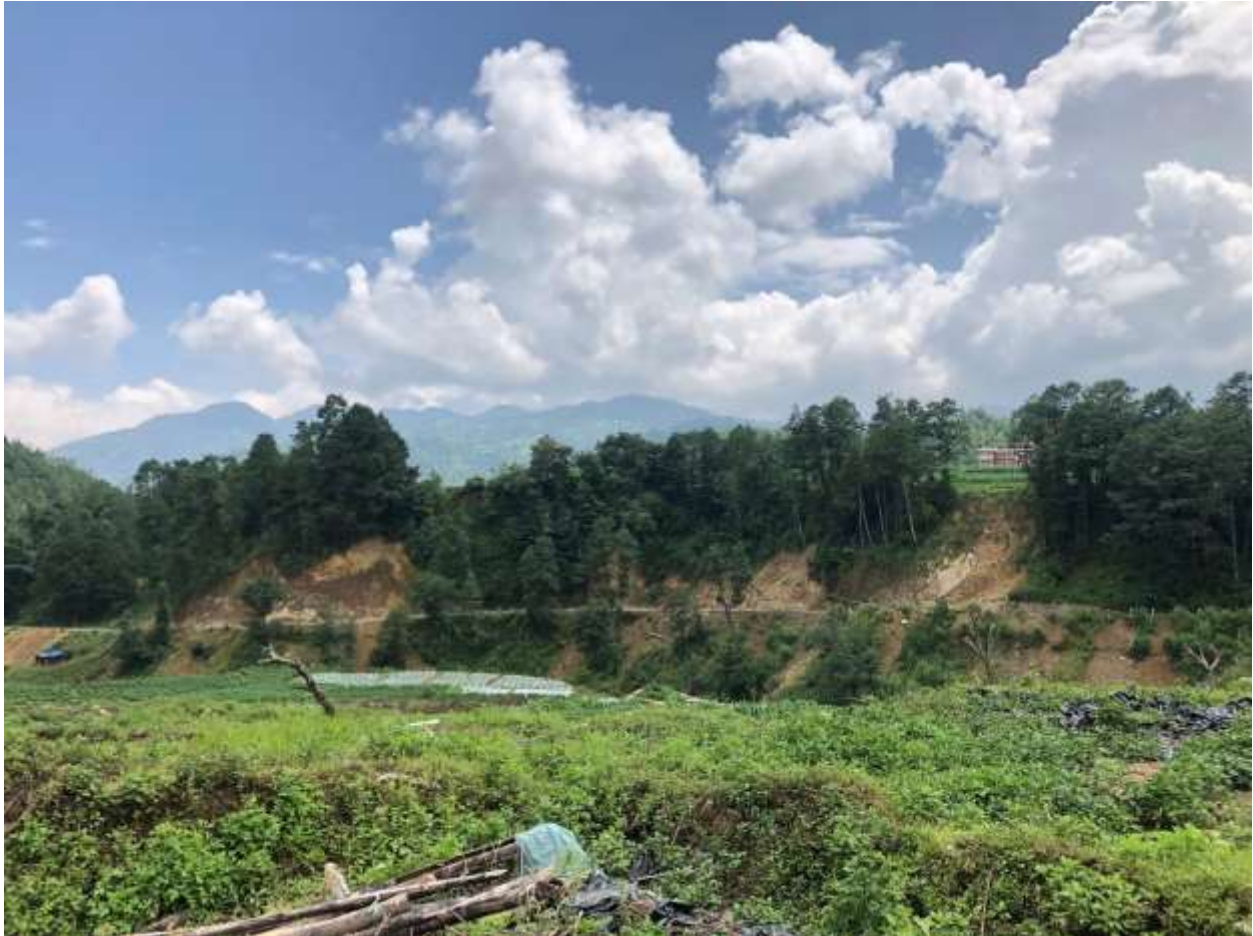
Road-cut failure of about 100 meters was observed at the Sarbang area along the main road to Bajrabarahi Bajar. Groundwater seepage was also observed during the study. Residual soil and ancient alluvial terrace deposit was the composition of landform. The rock type was Phyllite which is moderate-highly weathered and highly fractured. The bedrock orients NE/45 degrees.

The two types of failure modes; Wedge and plane failure was observed. Active gully erosion and dry debris fall is still active. This adds up the sediment down to Dhasku Khola meeting at the reservoir. The failures are shown in figure 15.

Figure 15: Road-cut failure observed at Sarbang area

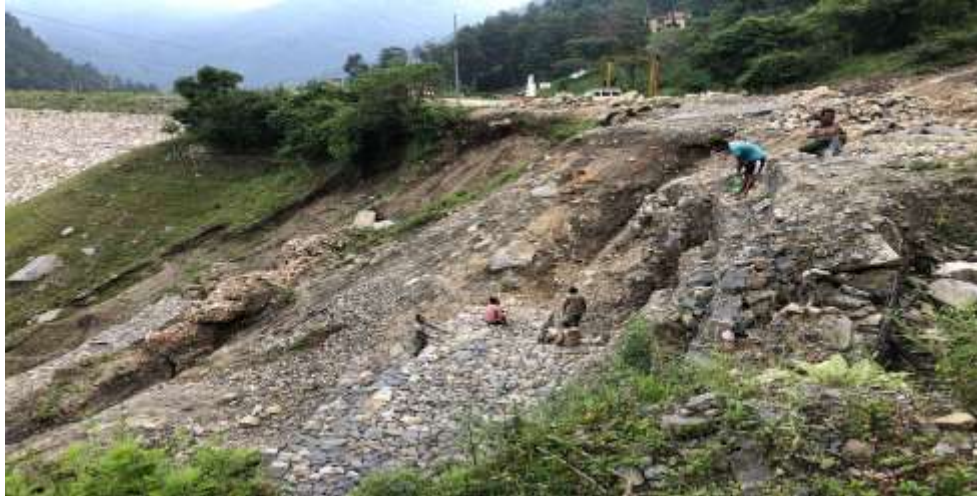
There is an active debris flow at E05-15-218 N30-52-986, Altitude: 1533 masl. It was activated in 2078 B.S monsoon period. The settlement on the upslope of failure is Dharampani Village. The sediment comprises Phyllite and Quartzite materials. There is still active erosional failure from the upper slope. Currently, control measures such as gabion works were under construction as shown in figure 16.

Figure 16: Landslide observed at dam site area

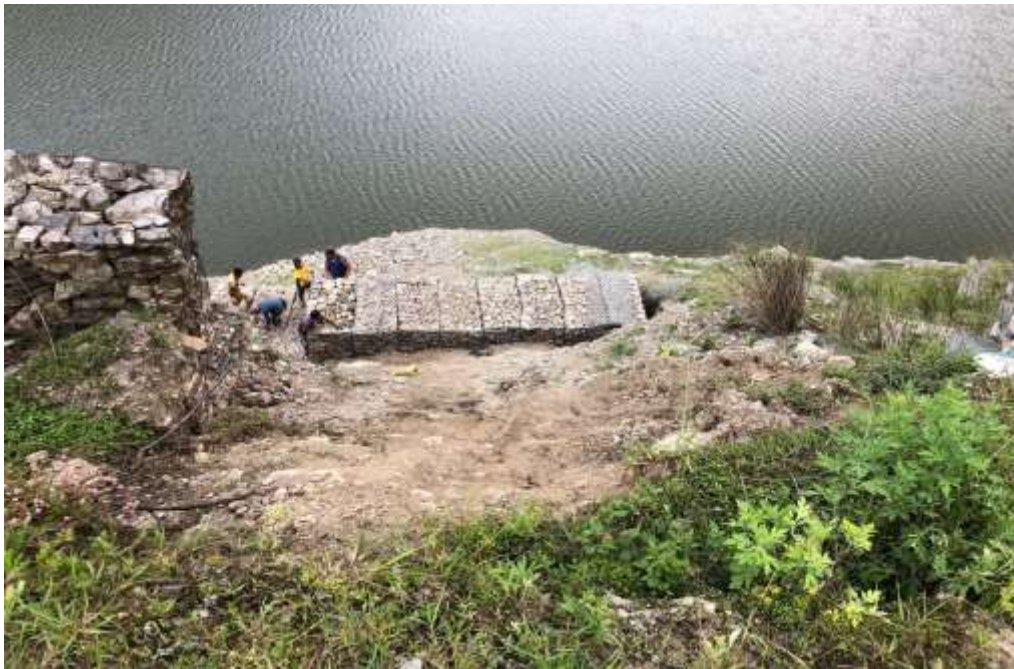
There was active erosion near a portal site at E05-15-545 N30-53-049 alt: 1538 m. Gabion wall construction work was undergoing to control the sediment transport to the reservoir as shown in figure 17.

Figure 17: Gabion works undergoing in an active erosional failure on loose sediment slope

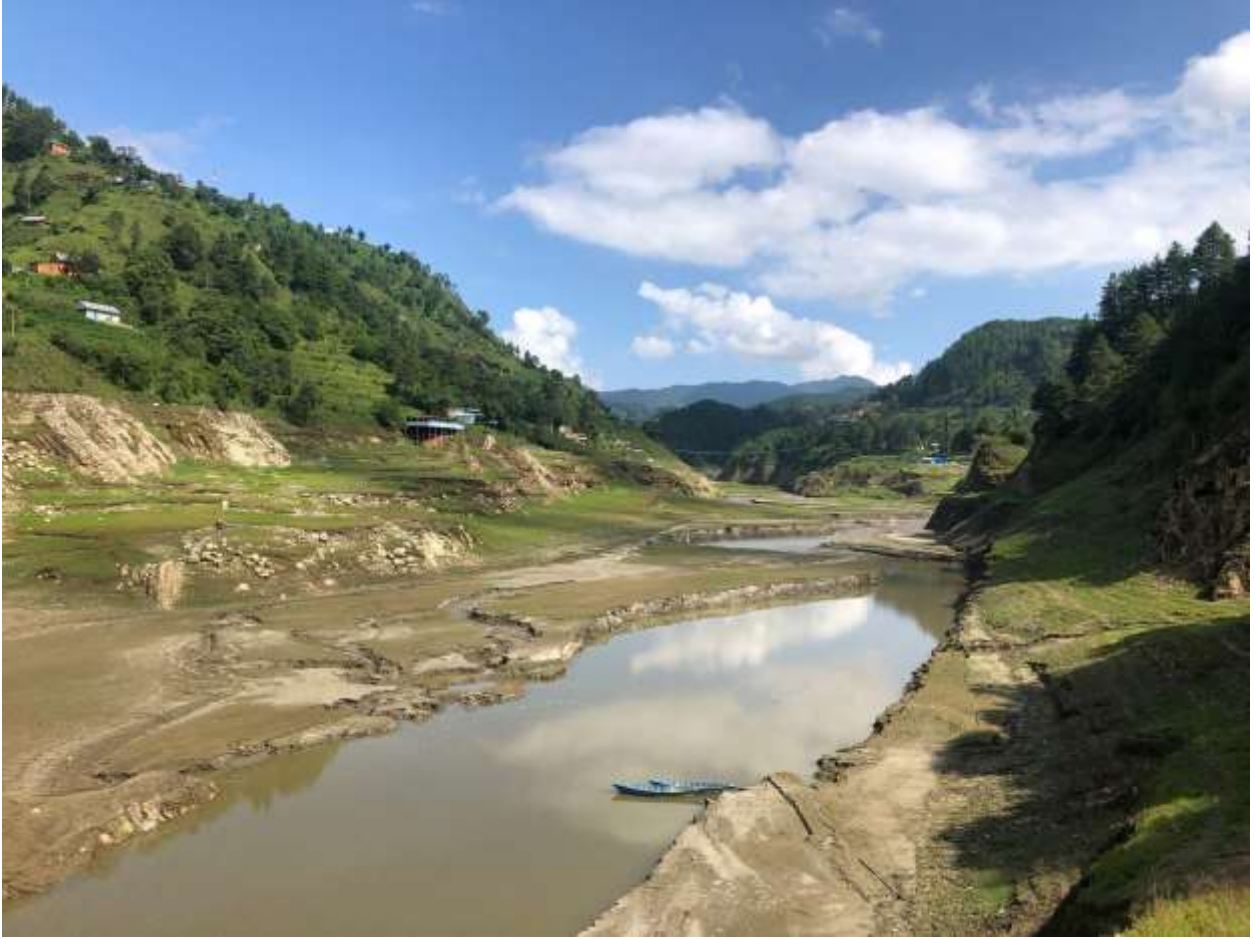
Figure 1: Sediment deposit along the reservoir beds (sand dominant); wpt: 2464

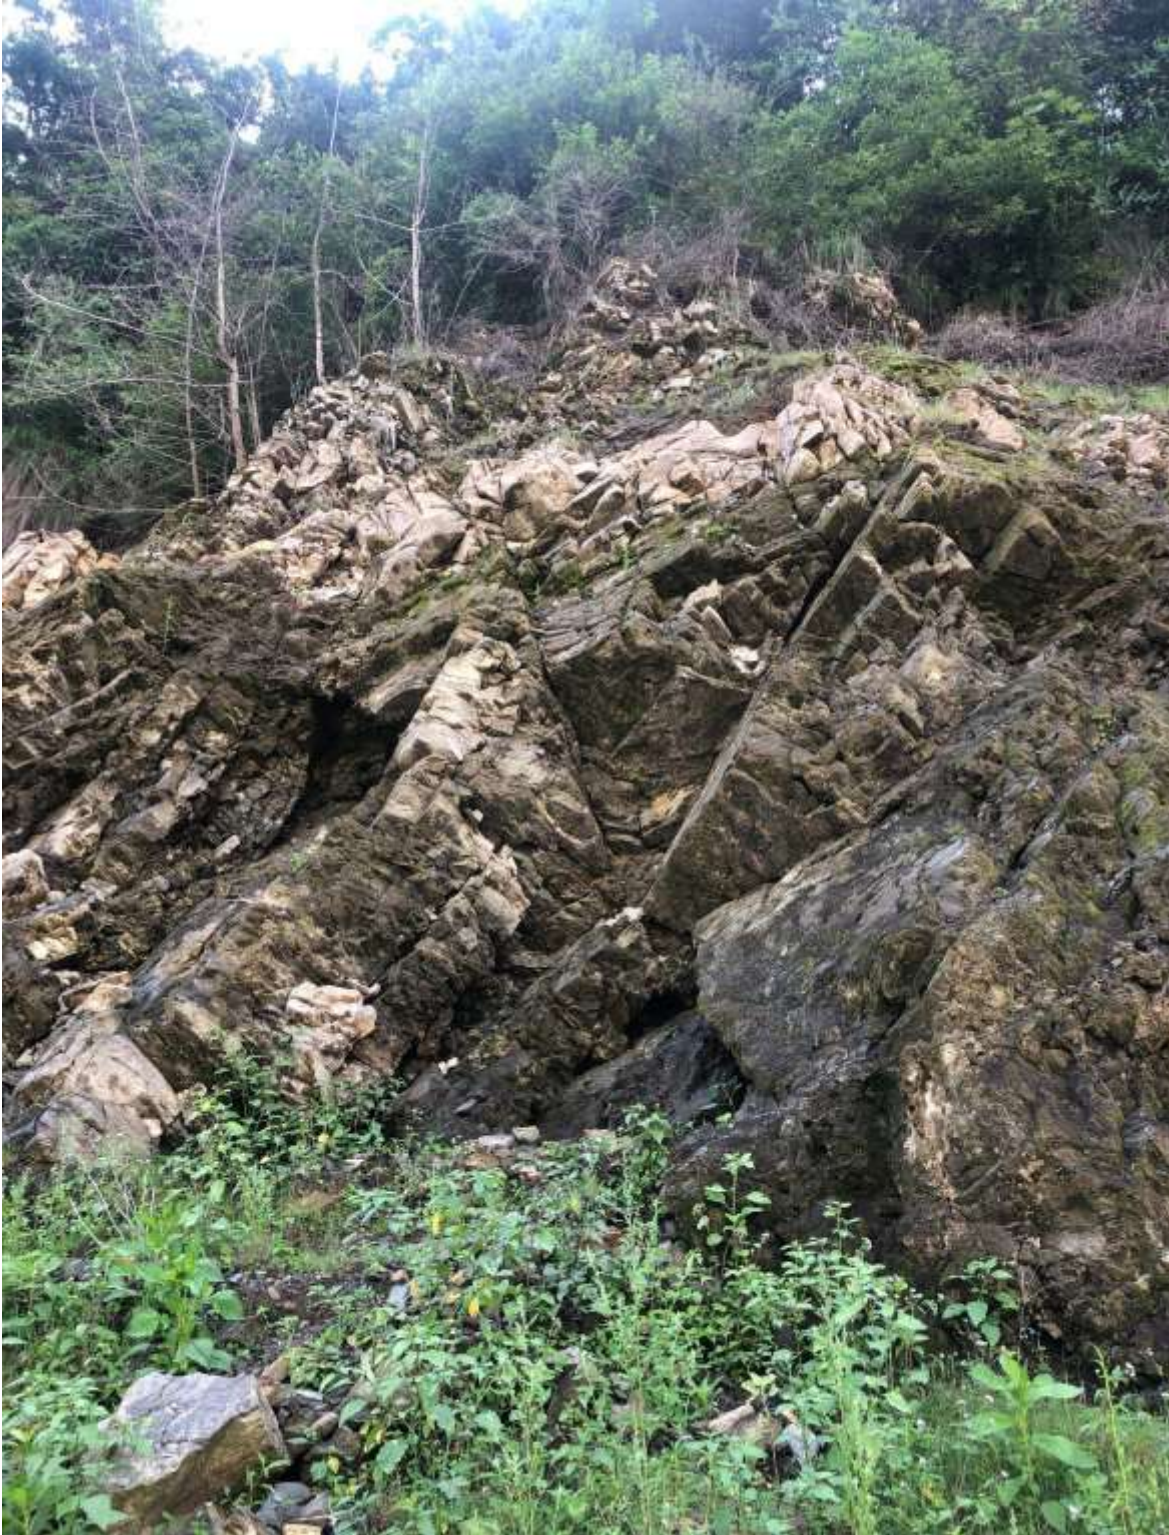
Figure 2: Unstable, wedge formation on the rock beds and potential sediment source site (wpt-2463)

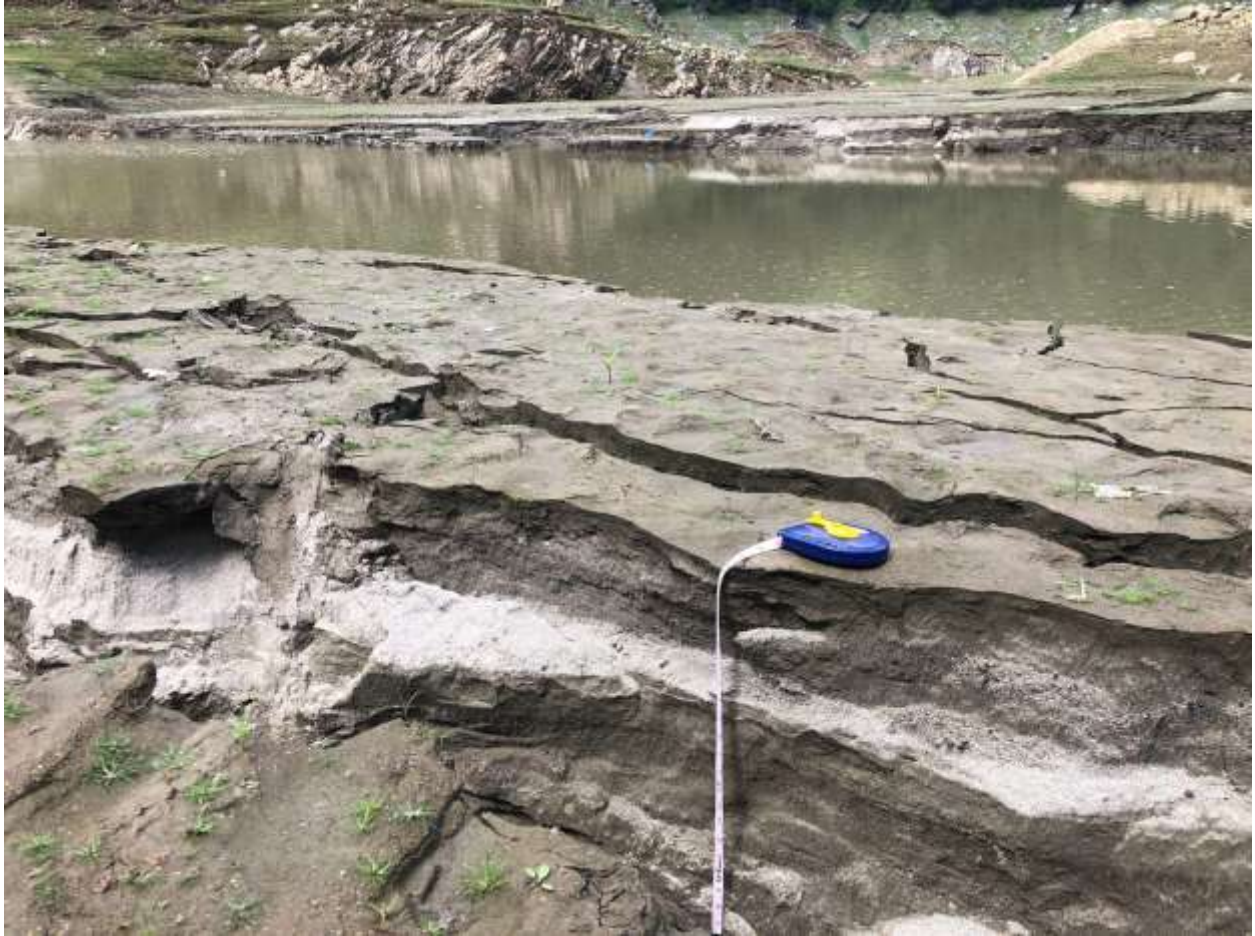
Figure 3: Sand deposit along the banks of Kulekhani reservoir, fissures formed due to undercutting by the water flow

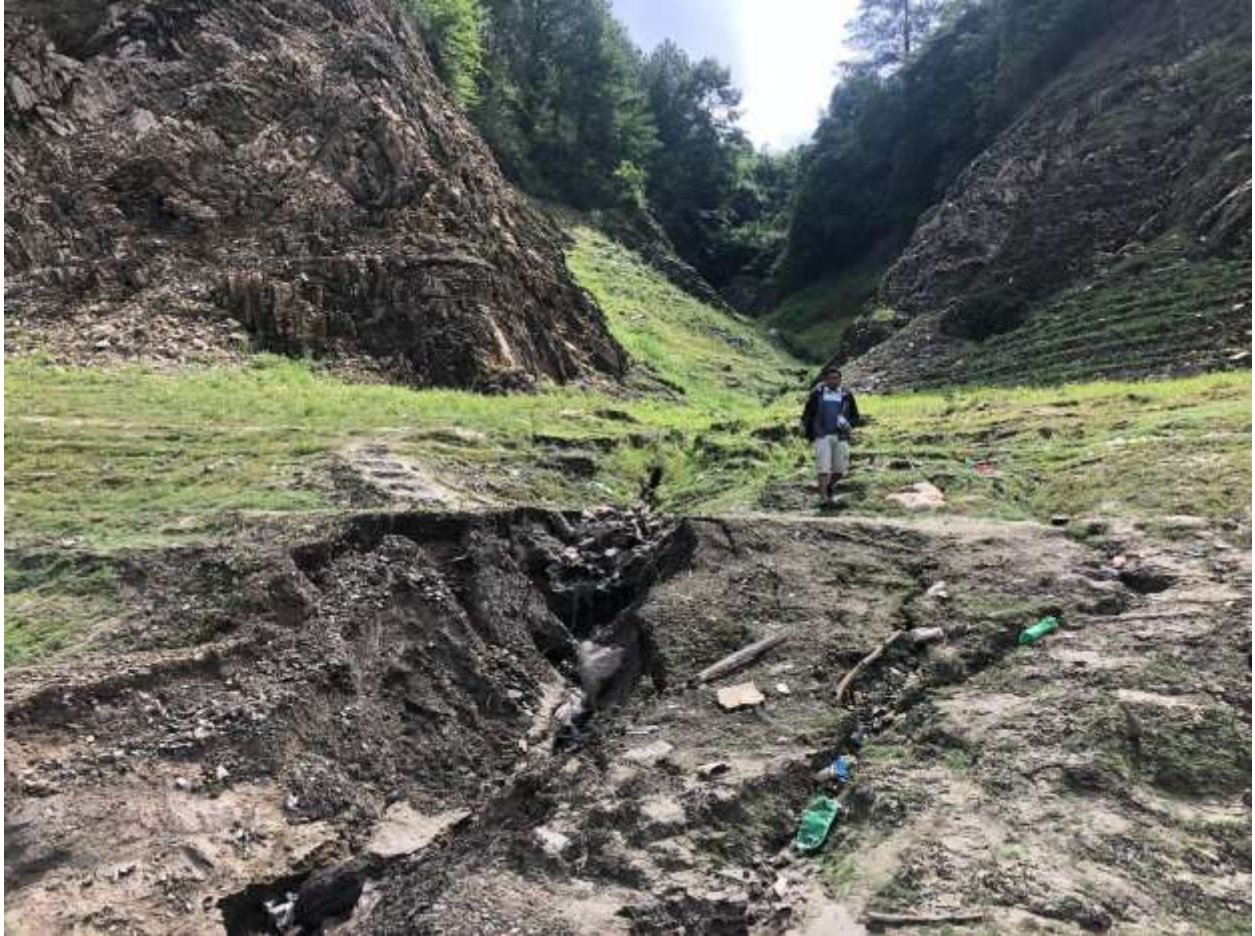
Figure 4: Erosion of the deposited sediments by a small stream meeting at Kulekhani reservoir (wpt:2465)

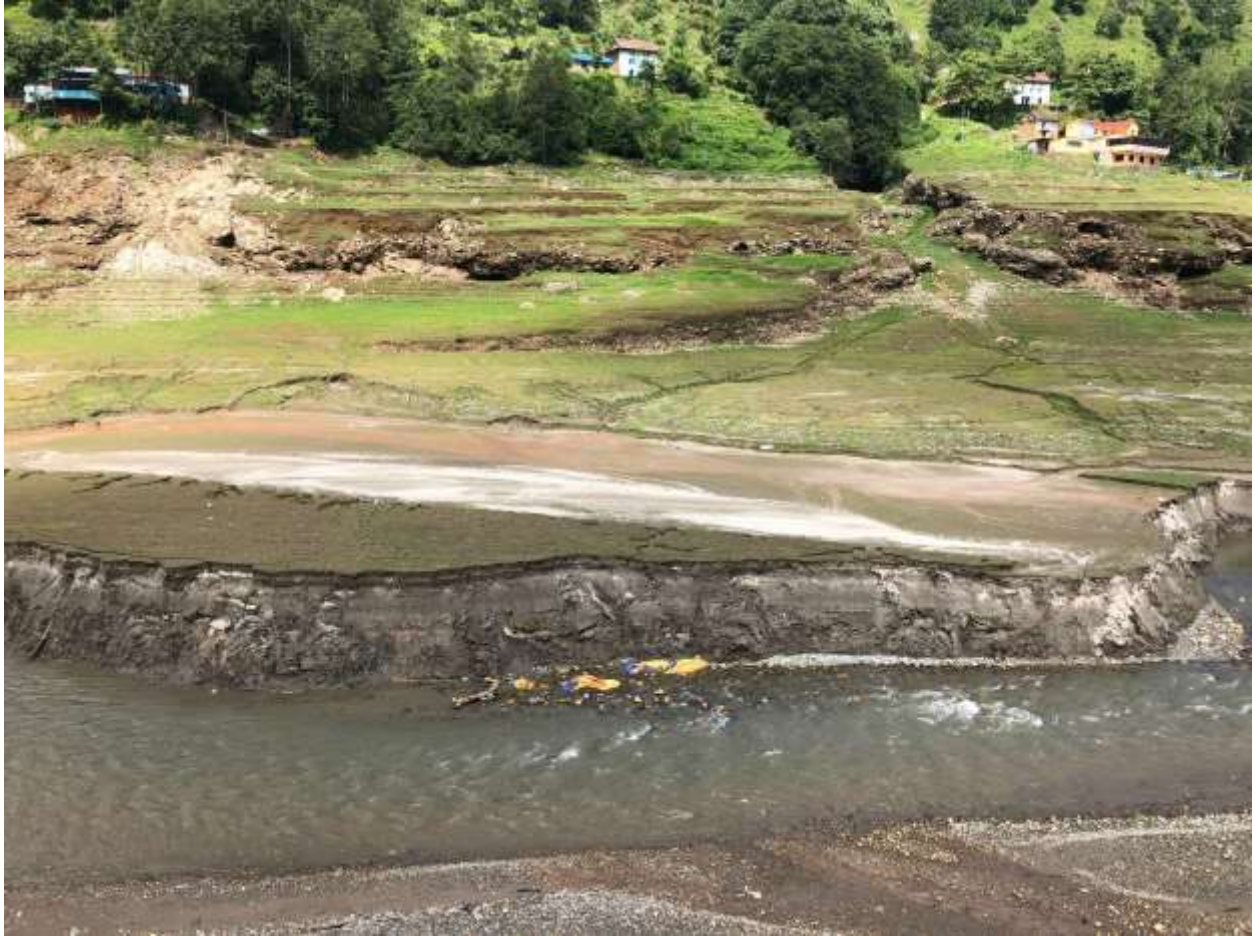
Figure 5: Sand bar deposit on the right bank of Kulekhani reservoir opposite of Chitlang Khola which meets at reservoir

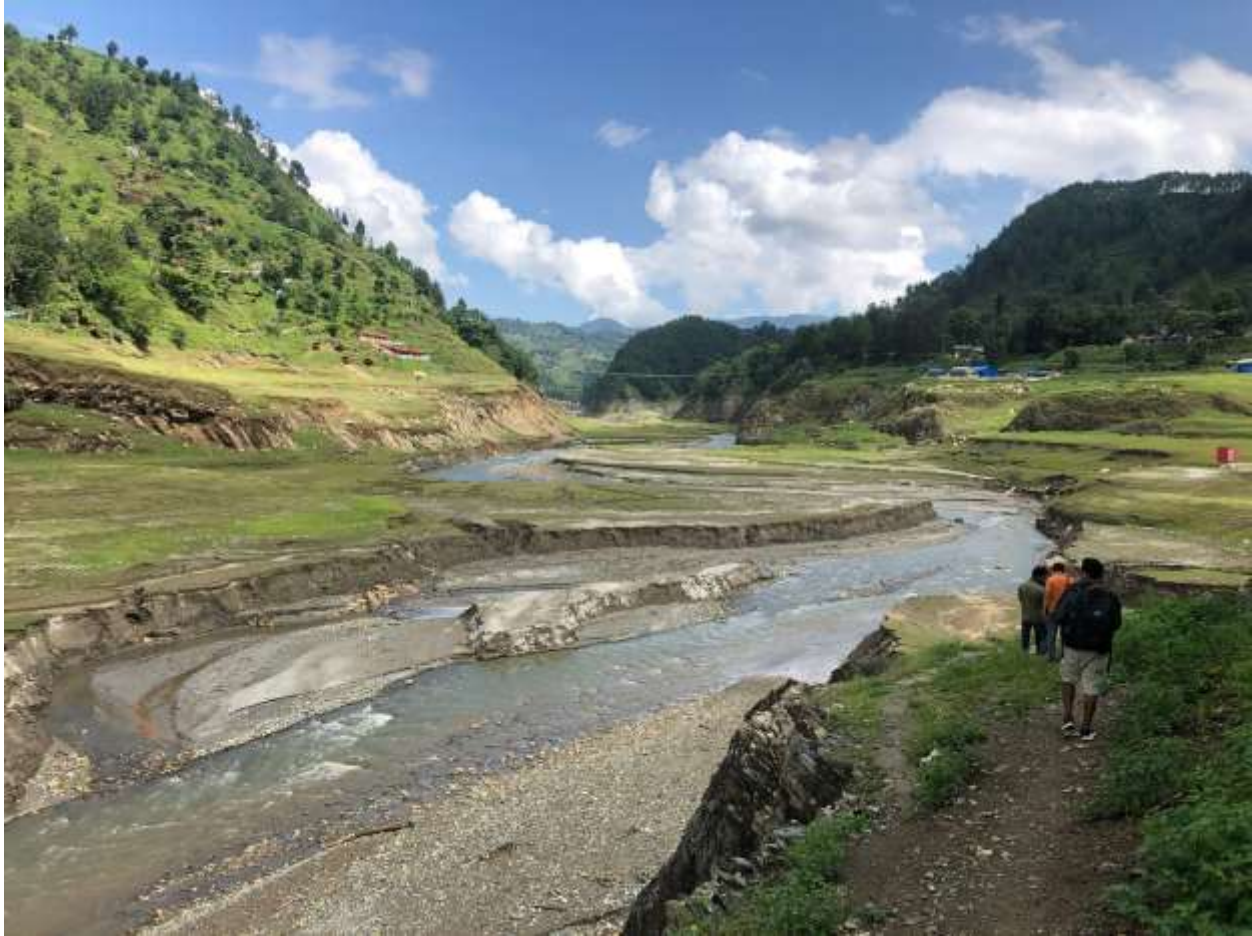
Figure 6: Decreased water level at the confluence of Kulekhani reservoir and Chitlang Khola (June 2022) It shows that there is an active sediment transportation during a heavy rainfall (rise of water level)
