Federal Watershed Management Resource Centre

**MEASUREMENT OF SEDIMENT DEPOSIT IN A SECTION OF
KHULEKHANI RESERVOIR AREA
MAKWANPUR DISTRICT**

**Submitted by:
Ink Consult Pvt. Ltd
Chakupat, Lalitpur**

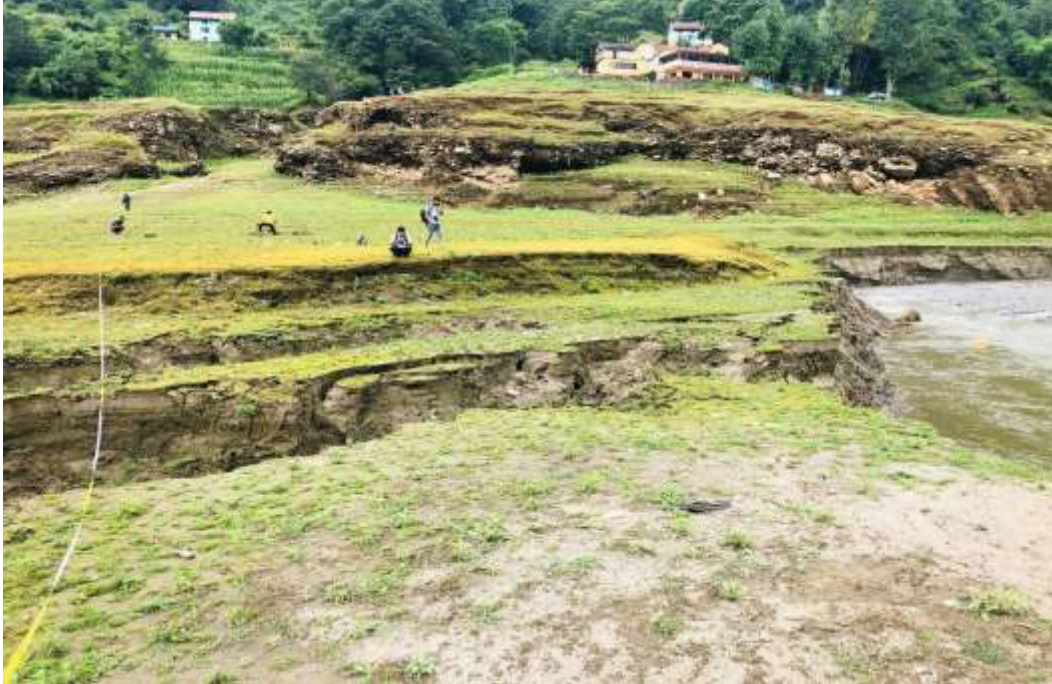
Figure 7: Measurement of deposition on the bank of rivers using tape meter

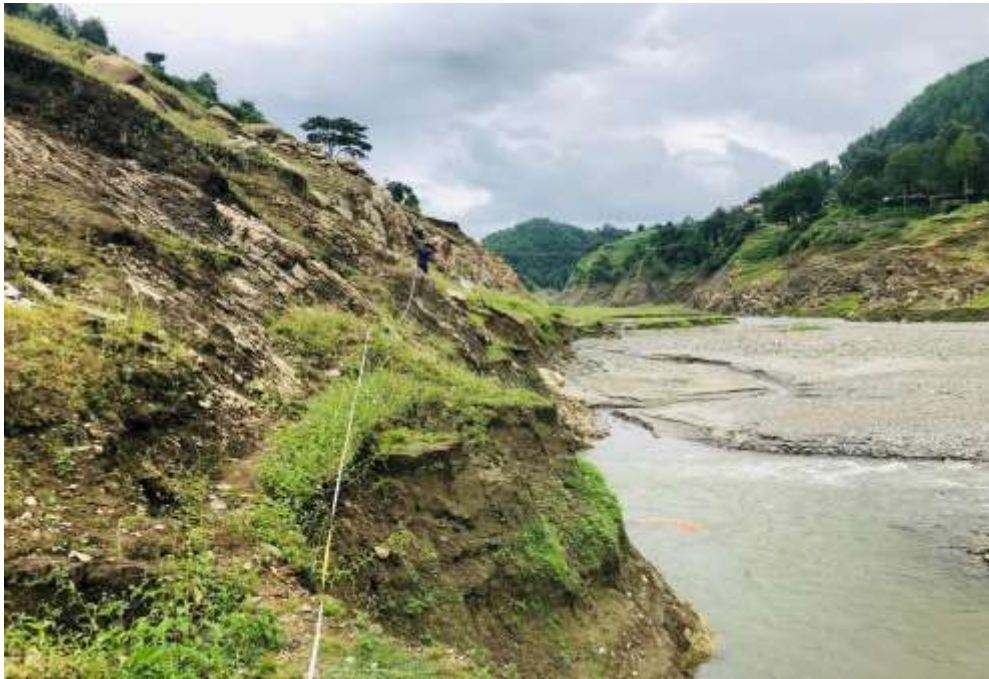
Figure 8: Measurement of slope cutting

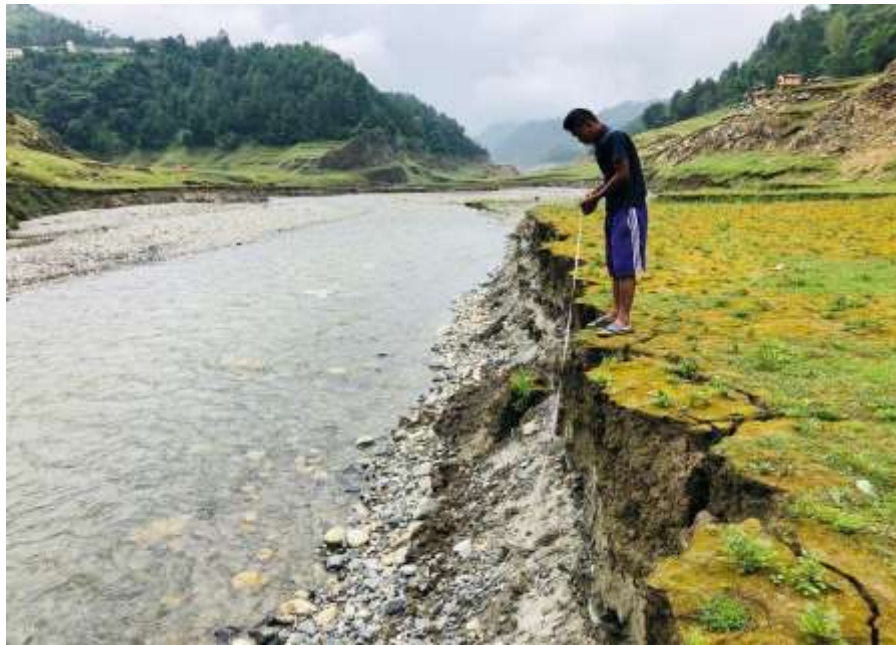
Figure 9: Measurement of deposition from the bed level of river

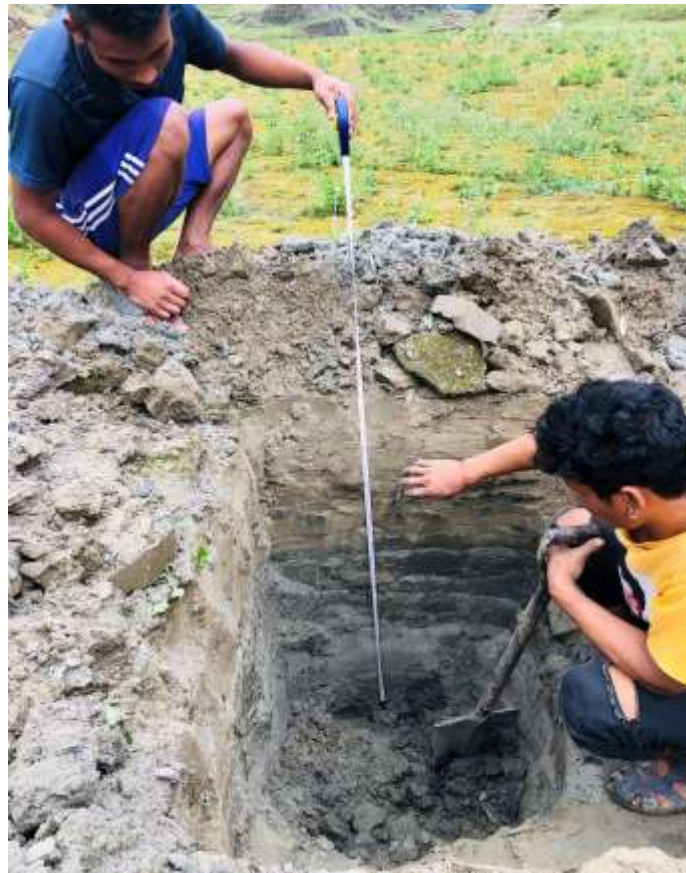
Figure 10: Measurement of old deposition by digging a pit

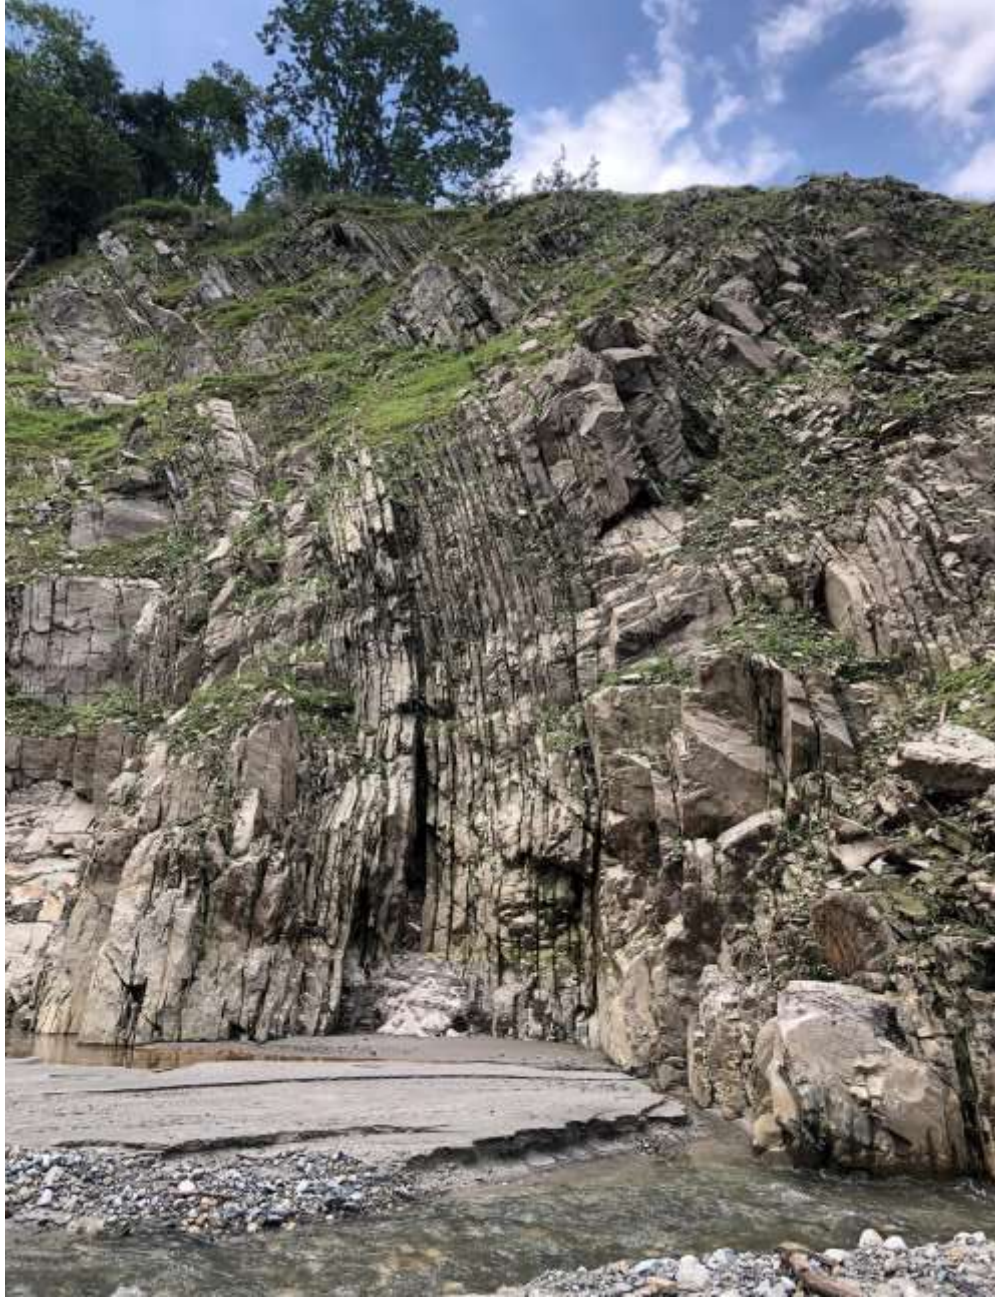
Figure 11: Alignment of rocks along the bank of reservoir

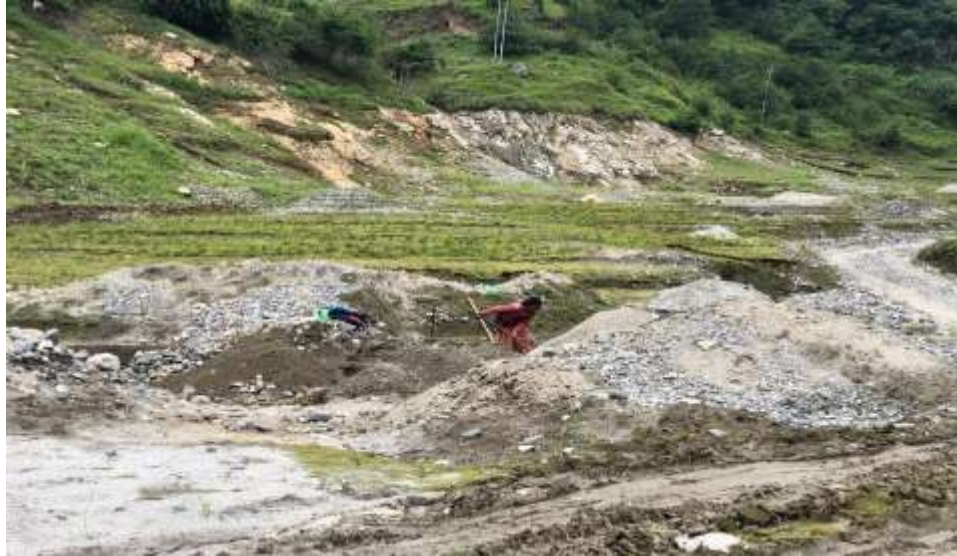
Figure 12: Excavation of deposited materials from the rivers

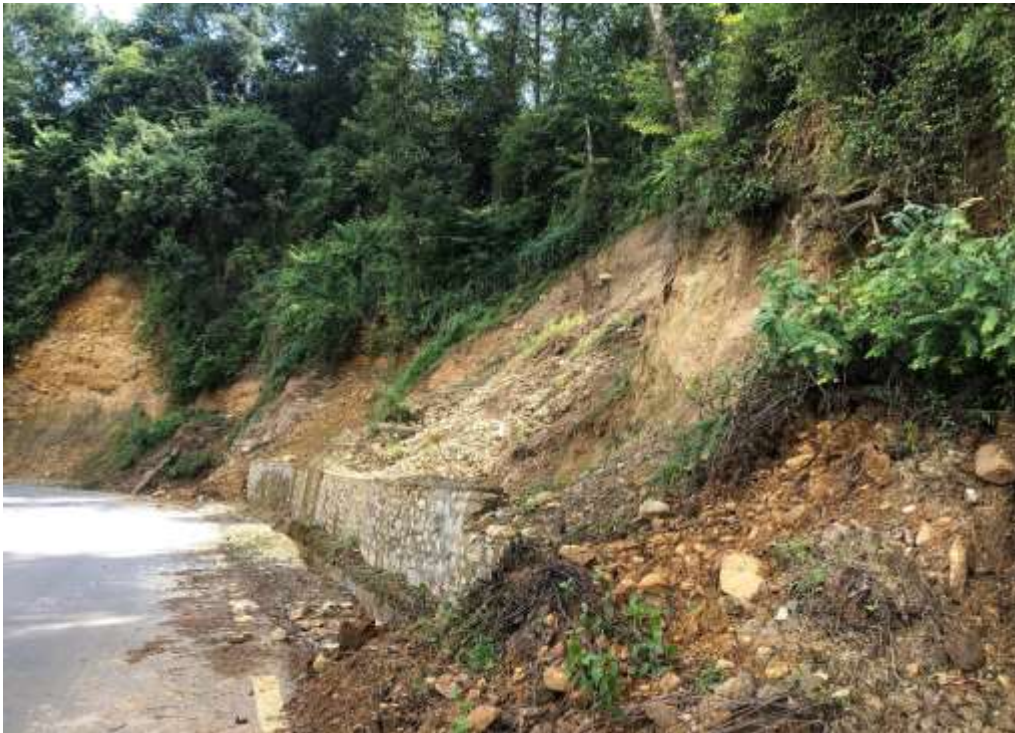
Figure 13: Landslides along the road
